“Flip” Syndrome, a new Mechanism of Lead Macrodislodgement of Cardiac Stimulation Devices

REV ARGENT CARDIOL 2024;92:160-162. <http://dx.doi.org/10.7775/rac.v92.i2.20756>

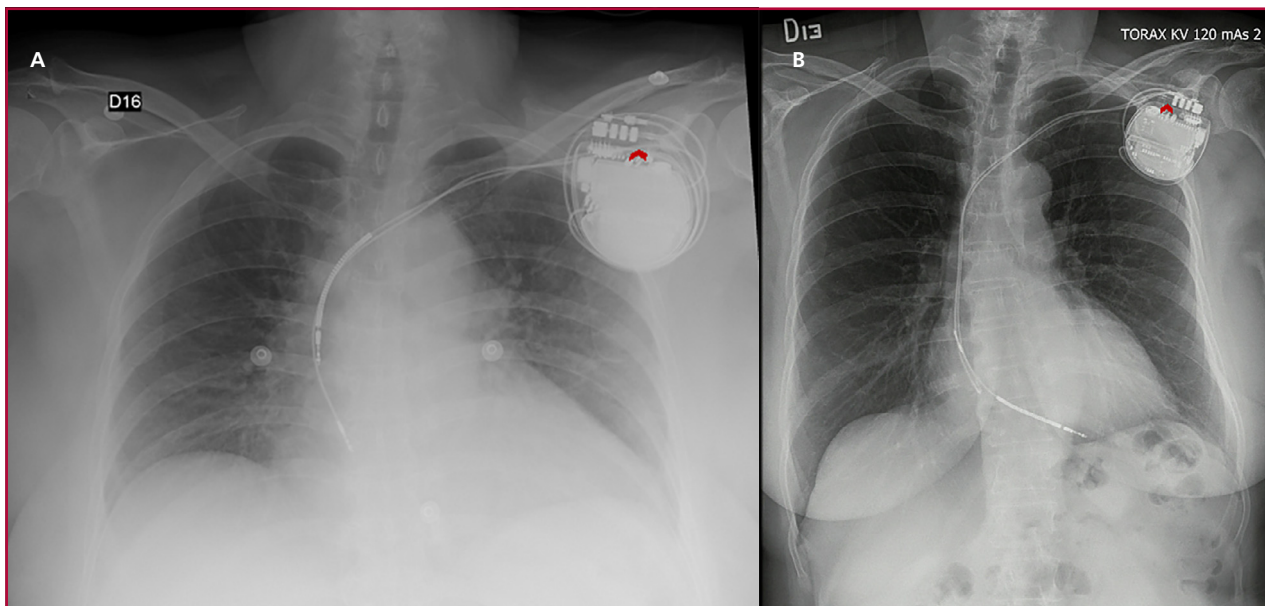
right ventricle without a lead inside it. The chest X-ray showed lead displacement; the atrial lead was located in the right atrium under traction and the ventricular lead was in the superior vena cava (Figure 1a). Additionally, the leads were observed coiled around the casing. Interestingly, a 180-degree rotation of the device in its sagittal axis was evident; the rotation was later on confirmed by comparing the connector location with the X-ray taken in the immediate postoperative period of the implant (Figure 1b). Therefore, it was suspected that lead dislodgement corresponded to a mixed mechanism, including ratchet and reel syndromes. The device was examined, revealing a normal battery and dysfunction due to defects in sensing and capture of the atrial and ventricular leads. No arrhythmias or shocks were recorded as active vibratory alerts, so the symptoms were not related to device shock.

During the procedure, the previously described findings on the chest X-ray were confirmed. These included a 180° ICD displacement in the sagittal axis with the device brand directed towards the posterior region (at the time of implantation this area had been positioned towards the anterior region), the casing fixation point was loose, there was lead retraction with clockwise rotation in the ICD short axis (reel) and a cogwheel mechanism on the fixing cap (ratchet).

An obvious deterioration of the leads and their endocardial fixation mechanisms was also documented, making their complete removal necessary. Given the extensive vascular stenosis, it was decided to insert a single ventricular lead, so the resulting device had a

Fig. 1. A. Initial chest X-ray upon arrival to the emergency room. Lead displacement is evident; the atrial lead is in traction in the right atrium and the ventricular lead is observed in the superior vena cava. Reel and ratchet syndromes are confirmed. The lead connectors are seen laterally directed (arrowhead), so a 180° rotation of the device in its sagittal axis is suspected. **B.** Chest x-ray in the immediate postoperative period after ICD implantation, five months before arrival at the emergency room. The lead connectors are seen medially directed (arrowhead).

Explantation and implantation of the ICD and repositioning of the leads under fluoroscopic guidance was scheduled for the next day.

unicameral configuration. The procedure ended without complications. The post-procedure chest X-ray showed adequate lead and generator positioning, so the patient was discharged within the next 24 hours.

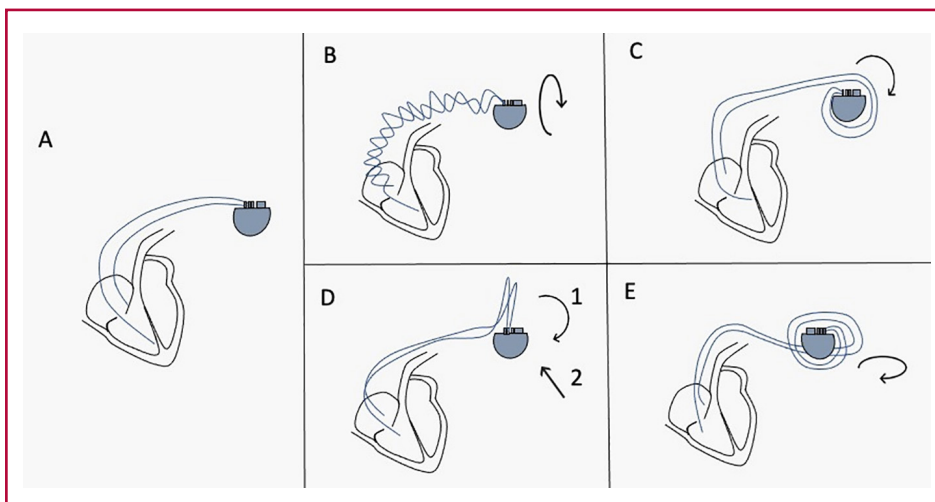
- Twiddler syndrome produced by the rotation of the generator on its long (axial) axis, which would correspond to the X axis in the Cartesian coordinate system, with lead coiling or twisting (characteristically in the form of a braid). This results in lead dislodgement or fracture, and, consequently, device dysfunction. (2)
- Reel syndrome occurs due to rotation of the pacer

maker generator on its transverse axis (short axis), which would correspond to the Z axis in the Cartesian coordinate system, with subsequent coiling (reel) of the pacemaker leads around the generator.

- The ratchet mechanism is produced by an initial lead retraction, followed by a ratchet (cogwheel) mechanism. It is caused by the progressive retraction of the leads from their fixing protections, without twisting or wrapping around the device. Furthermore, it is associated with a lateral displacement of the generator in the frontal plane. (1)

Fig. 2. A. Normal arrangement of leads and generator. **B.** Twiddler mechanism. **C.** Reel mechanism. **D.** Ratchet mechanism. **E.** New mechanism described with rotation in the sagittal axis of 180°: flip mechanism.

the “burning” sensation caused the progressive rotation of the generator. Although coiling of the leads around it, known as reel syndrome, and the lateral displacement of the generator along the frontal plane, known as ratchet syndrome, can explain lead dislodgement and device dysfunction, in this particular case a different mechanism was observed. This was a macrorotation not previously reported in the literature, where the generator is flipped 180 degrees on its sagittal axis, which would correspond to the Y axis in the Cartesian coordinate system. As a result, the brand letters were oriented towards the posterior region, favoring lead retraction and dislodgement (Figure 2). Therefore, it is proposed to call this phenomenon “flip” syndrome or mechanism.

Diagnosis is made by chest X-ray and treatment depends on the underlying mechanism. In the case of the reel syndrome, lead repositioning is the most common strategy. On the other hand, in the twiddler syndrome, leads are replaced in most cases due to the higher frequency of fracture/damage. Additionally, in some specific cases the device pocket can be remodeled. Several strategies have been proposed to prevent device rotation, such as creating a small pocket, subpectoral implantation of the device, use of nonabsorbable or polyester fixation sutures, and the use of active fixation leads and even immobilization of the upper limb in the first week after implantation. (4)
